## Survey Report of Liquefaction Damage of Urayasu Area

### ABSTRACT

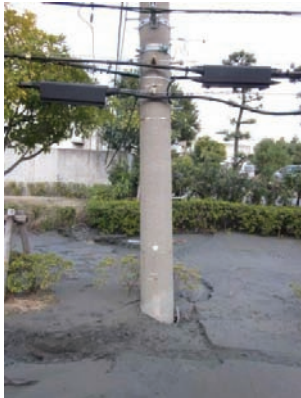
Although severe damage by liquefaction was observed in the reclaimed land area from Route 357 to Tokyo Bay, as shown in Fig.1(b), Photo.6 and Fig.2, very little liquefaction has been reported in the original old land area in Urayasu city. Photo 1~3 show damage of roads, sidewalks and ground surface which was covered by the boiled sand due to liquefaction. Photo.4 shows a manhole which was found to protrude the ground surface after the earthquake.

Photo.1 An electricity pole filled with boiled soil (Chidori area)

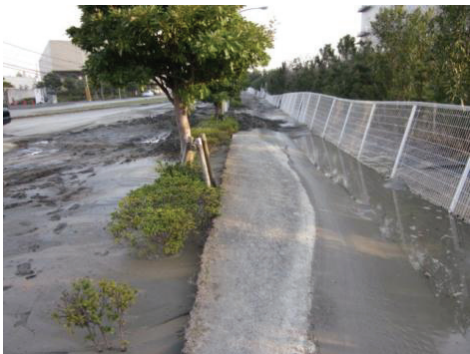
Photo.2 Ground surface covered by boiled sand (Chidori area)

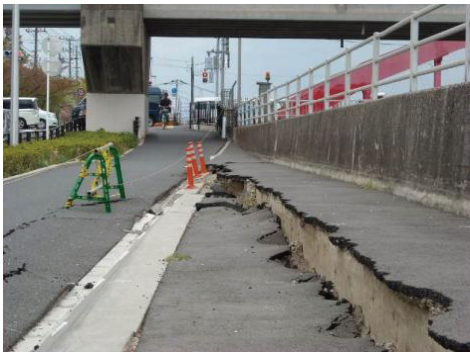
Photo.3 Difference of sidewalk height (right side: old levee) (Imagawa area)

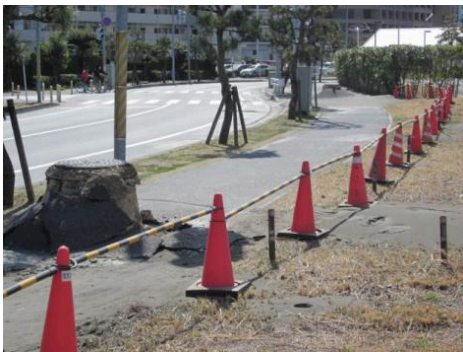
Photo.4 A protruding manhole in sidewalk (Hinode Area)

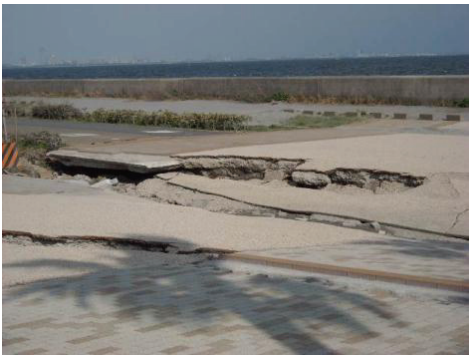
Photo.5 Sinking of soil near old levee (Hinode area)

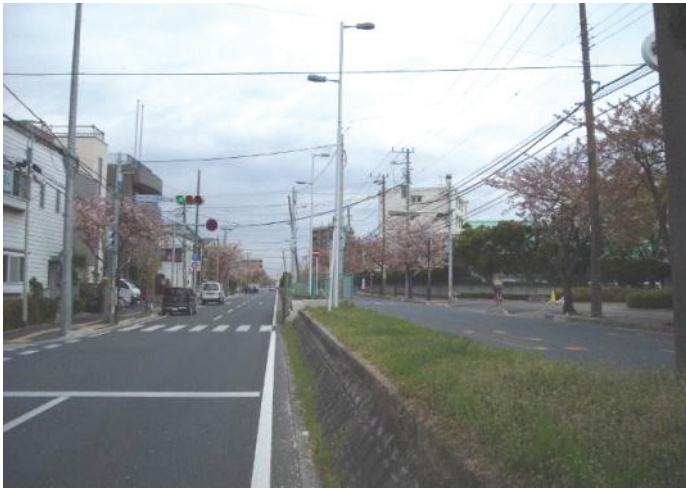
Photo.6 and Fig.2 show the boundary between Tohno area (right side; newly reclaimed land area) and Fujimi area (left side; original old residential area), and also the cross section of these two areas respectively. Right side of the road located in Tohno area was reclaimed with the same height to the old levee, and difference of road height between the right and left sides was about 80cm. As shown in Photo 6, damage level caused by liquefaction apparently depends on the ground condition where sand boiling was observed on the sidewalk

of Tohno area (right side; reclaimed land area), and contrarily, was not observed at all in the Fujimi area (left side; old residential area).

Photo.6 Boundary of newly reclaimed land and old residential areas in the Route 357 (small retaining wall just located in the center)

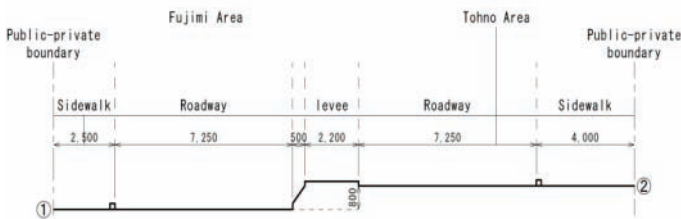
Fig.2 Cross section of boundary of newly reclaimed land and old residential area in the Route 357 (refer to Fig.3)

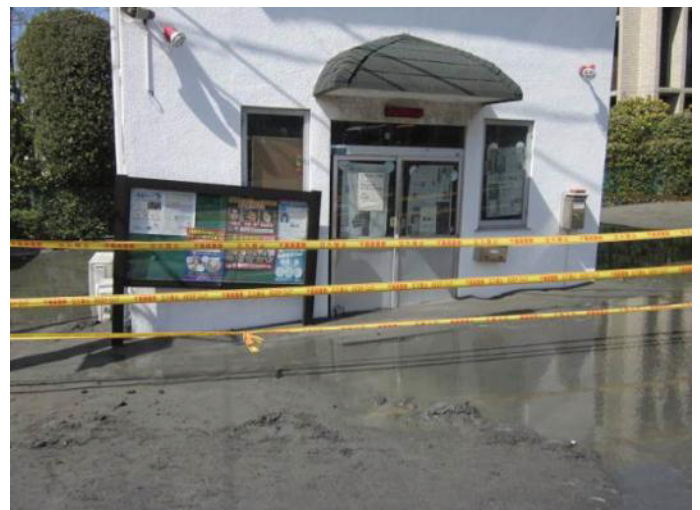
Similar to the roads and sidewalks already described, damage levels caused by liquefaction to buildings and detached houses were closely related to the location. Photo 7 and 8 show Tomioka police box with part of its door filled with soil due to sand boiling and subsidence, and an inclined and damaged outer wall of a factory, respectively. From these photos, negligible uneven settlement of foundations and a large quantity of boiled sand caused by liquefaction can be easily observed. On the other hand, despite the world's largest earthquake with 9.0 of magnitude and level 7 of maximum seismic intensity (level 5 + in

Photo.7 Uneven settlement observed at a police box

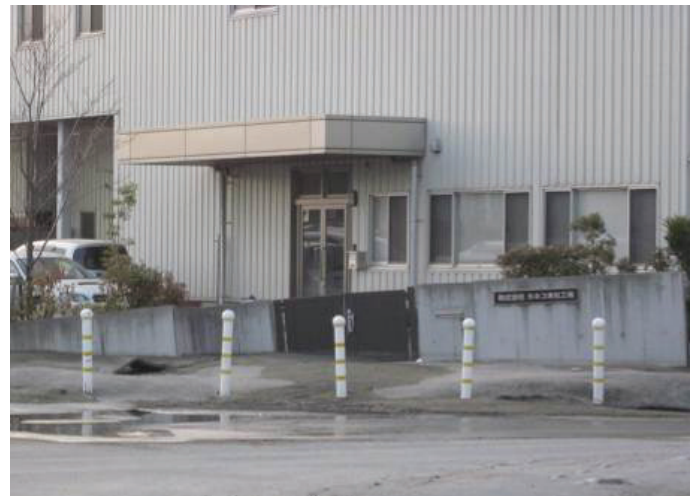
Photo.8 Inclined outer wall of a factory caused by sand boiling and subsidence

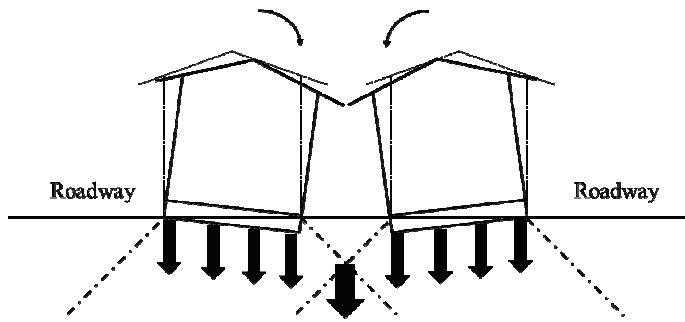
Serious damage of detached houses such as inclined outer walls was observed in the residential areas, especially in the Imagawa, In the Benten and Imagawa areas, many detached houses were inclined toward the opposite side of roads, as shown in Fig.5. On the other hand, very small damage was observed in apartment houses built by the Housing Corporation in the Benten area, due to the fact that the apartment houses had already been reinforced by ground improvement methods.

Fig.5 Inclination of detached houses

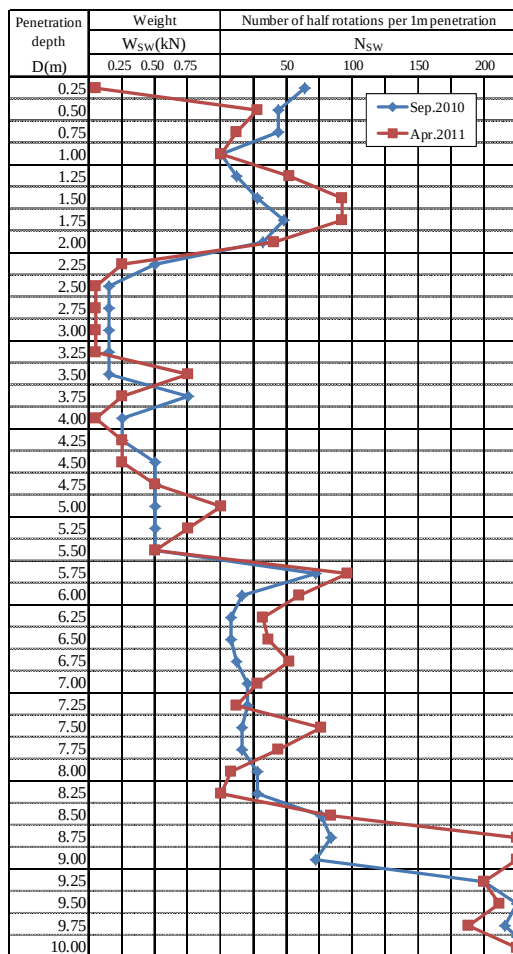
From Fig.7, relatively dense sand is observed from ground surface to 2m deep, and this sand layer is considered to be newly reclaimed soil. Between 2m and 5.5m deep, weak soil layer is observed continuously, and it is supposed that liquefaction occurred in this layer. Very dense soil layer appeared lower than 10m deep, and penetration of the SWS test rod was impossible at that point. The groundwater level was measured by the Alternating Current resistivity sensor using the SWS test holes simultaneously with the SWS tests, and was found to exist at a very shallow depth (1.10m deep from the ground surface). It is also understood by the SWS test results that although there is no noticeable difference, the soil after the earthquake gives a little more strength compared to before the earthquake.

Fig.7 Result of the SWS test (Imagawa Area)

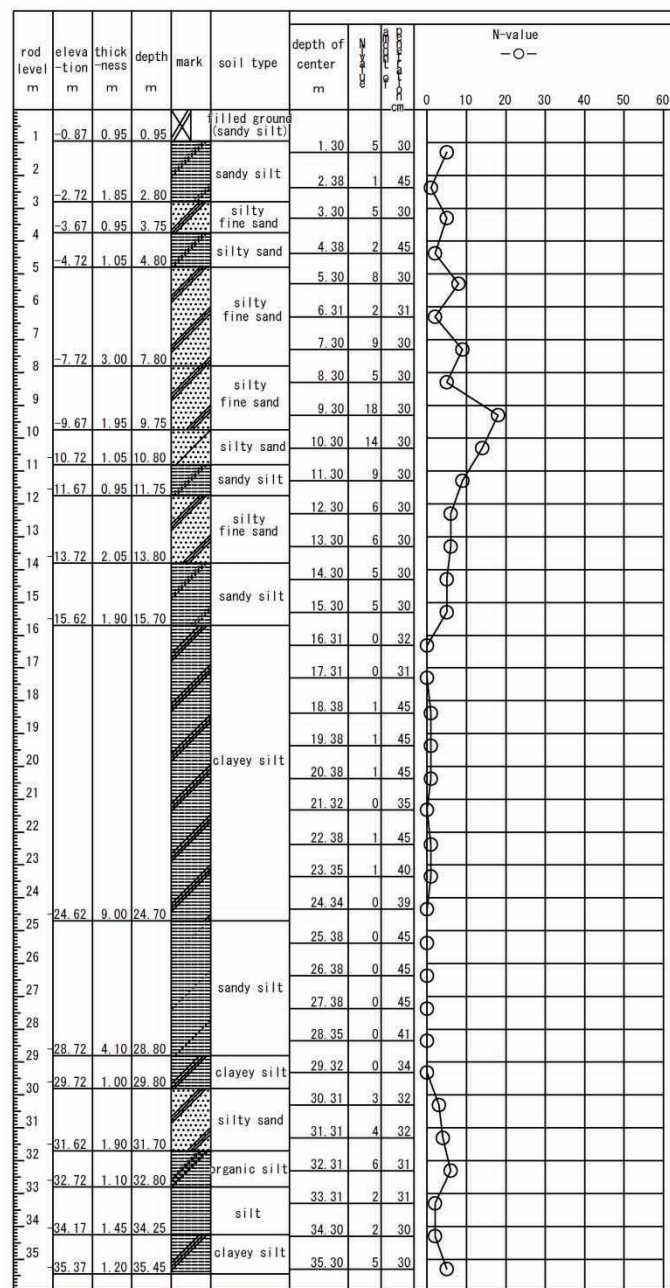
Fig.8 Soil boring log at Imagawa Area

Judgment of liquefaction possibility based on the “Design Manual for Building Foundation in Japan” was carried out using the boring log data as shown in Fig.8. PL value of 7.90, which means “possibility of liquefaction is large”, was calculated when 160 gals of the maximum horizontal acceleration and Magnitude 9 were assumed based on the observed seismic wave near the site. On the other hand, as it has been

pointed out that the grain size distribution and relative density of soil may be changed before and after liquefaction and sand boiling, care is necessary when evaluating the possibility of liquefaction using boring log data obtained after the earthquake. Since the soil condition may become a little denser after liquefaction, as shown in Fig.7, possibility of liquefaction will be underestimated when using the boring log data after the earthquake. In addition, as the re-liquefaction of soil may take place when the next earthquake occurs, it is worthwhile to investigate an effective countermeasure to liquefaction in advance. When considering the foundation types and reinforcement methods with regard to the ground condition for detached houses, it is an important reminder that the result of the conventional judgment for liquefaction possibility may not be always on the safe side.
