Deformation of Retaining Walls Caused by Construction of Soil-Cement Column

KEY WORDS: Retaining wall, Soil-cement column, Deformation

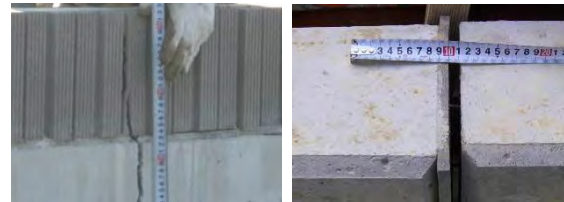
Fig.1 Deformations of retaining wall

However, it is difficult to carry out the suitable countermeasure to the displacement of the retaining wall because the mechanism and cause are not clear (see Fig.1). In this chapter, we show the results of a survey on deformation cases.

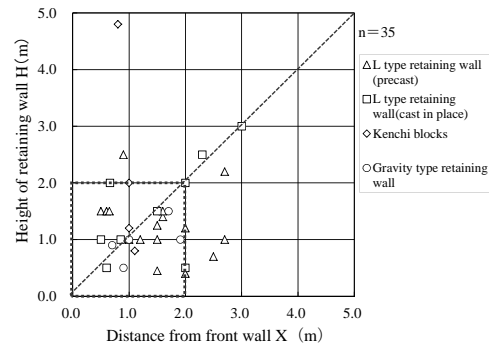
Fig.6 Relation between height and distance

In Fig.6, a graph of the relationship between X (the distance of the soil-cement column position from the front retaining wall) and H (retaining wall height) is shown. As shown in Fig.6, deformations occur within the first 2 meters from the ground.

It may be due to the fact that retaining walls of less than 2m in visible height is not subjected to the regulation of the Building Standards Law and the Law on the Regulation of Housing Land Development in Japan, and the retaining wall structure is not enough to satisfy the adequate specification. The retaining wall of less than 2m in visible height is

easily deformed by lateral earth pressure because weight of backfilling and its own weight are relatively small. In those cases, it is necessary to examine soil-cement column position and construction sequence in the design phase.

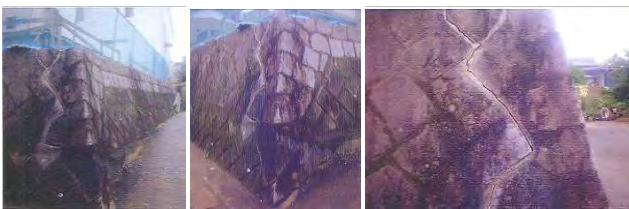
Fig.9 Deformation of retaining wall (case1)

Joints of retaining wall were cracked after the soil-cement column had been constructed in the land where old masonry retaining walls existed. Soil-cement column was constructed by 11t class machine. Fig.9 shows the retaining wall joints. If there is old masonry retaining wall on site, it is necessary to consider the possibility of deformation occurring when applying ground improvement work.

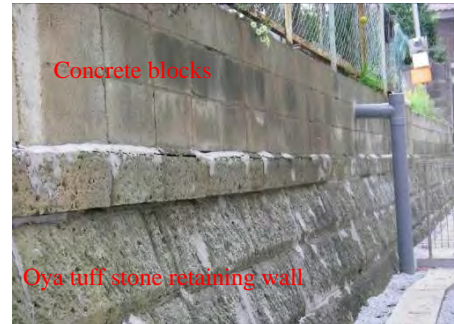
Fig.10 Example of Oya tuff stone retaining wall

The CB was cracked when the soil-cement column was constructed in the housing site where the CB was constructed on top of Oya tuff stone retaining wall. Example of the Oya tuff stone retaining wall is shown in Fig.10. This site is estimated to be cohesive soft clay ground from the location. Soil-cement column was constructed by 6t class machine.

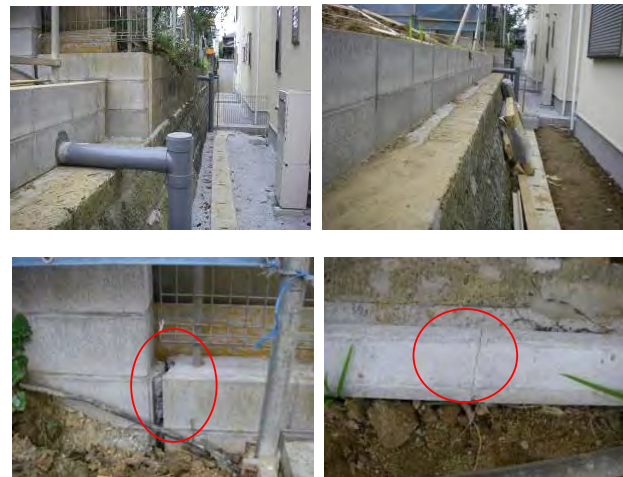
Fig.11 Deformation of retaining wall (case2)

Column's diameter was 500mm and length was 3.5m. Fig.10 shows crack of the CB. Crack was found in the the CB when leveling the ground, and was 3cm width at most. The cause is considered to be related to speed of the extraction, excavation and the cement slurry injection. It is inferred from the crack condition of the CB that the soil pressure had affected the lower part of the retaining wall.

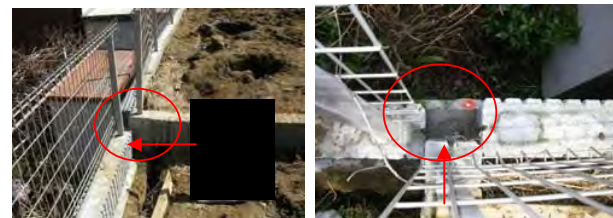
Fig.12 Deformation of retaining wall (case3)

The masonry retaining wall and concrete blocks were deformed by the lateral earth pressure when the soil-cement column was constructed. This site is estimated to be cohesive soft clay ground. The Soil-cement column was constructed by 6t class machine. Column's diameter was 500mm and length was 7.0m. Fig.12 shows deformations of the masonry retaining wall and the CB. The Soil-cement column was constructed away from the retaining wall because the retaining wall and column position was close. However, deformation and cracks in the block joints occurred in the masonry retaining wall.

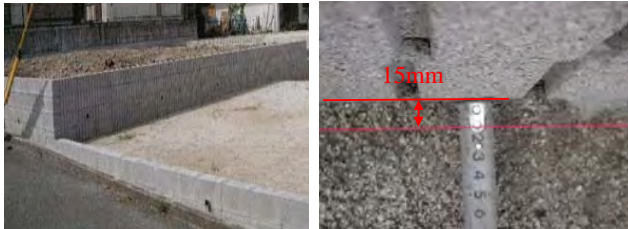
Fig.13 Deformation of retaining wall (case4)

5 block high retaining wall was displaced when the soil-cement column was constructed in the housing site. The Soil-cement column was constructed by 8t class machine. Column's diameter was 500mm and length was 5.0m. Fig.13 shows displacement of the CB. Preceding excavation was carried out at soil-cement column position for the soil pressure reduction because the retaining wall and column position was close. However, the displacement of about 15mm occurred in the CB. The cause is presumed that the counterfort 800mm protruding from CB was affected by the lateral earth pressure.

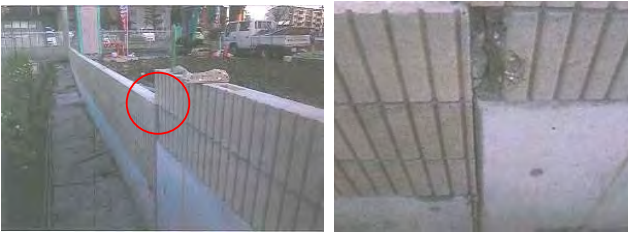
Fig.14 Deformation of retaining wall (case5)

2 block high retaining wall added on top of the existing gravity type retaining wall was damaged. The soil-cement column was constructed by 8t class machine. Column's diameter was 500mm and length was 4.5m. Fig.14 shows crack of the CB. Workers had to check the condition of the retaining walls during construction. However, the CB and gravity retaining wall was cracked after the completion of construction. Cracks did not occur when soil-cement column was constructed near the retaining wall. The cause is considered to be the inflation pressure due to solidification of the soil-cement column.

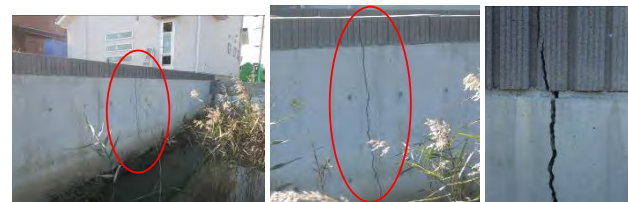
Fig.15 Deformation of retaining wall (case6)

The gravity type retaining wall was cracked about 5mm at the center of wall when the soil-cement column was constructed. Soil-cement column was constructed by Pole erection vehicle. Column's diameter was 600mm and length was 3.5m. Fig.15 shows crack of the gravity retaining wall. Largest amount of confirmed displacement damage is 20mm. The length of the retaining wall was 10m or more, but there were no drainage holes and expansion joints. Cause is presumed to be structural defects of the retaining wall.

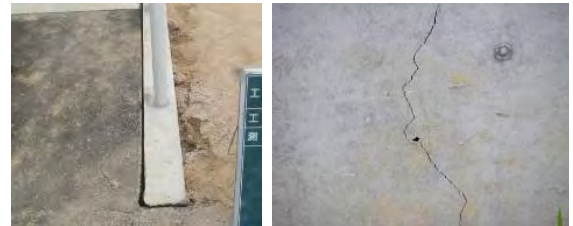
Fig.17 Deformation of retaining wall (case8)

The L-type retaining wall (cast in place) was displaced and cracked when the soil-cement was constructed. Height of the wall was 1800mm and length of deck slab was 1300mm. The Soil-cement column was constructed by 8t class machine. Column's diameter was 600mm and length was 8.5m. Fig.17 shows crack and displacement of the L-type retaining wall (cast in place). Deck slab of the retaining wall had been checked before soil-cement column was constructed. In addition, in spite that the construction sequence and column position were examined, the deformation occurred by the soil-cement column construction.

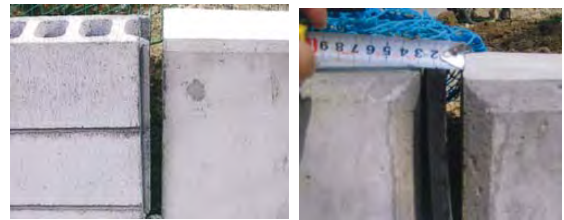
Fig.18 Deformation of retaining wall (case9)

The L-type retaining wall (precast) was deformed when the soil-cement column was constructed. Height of the wall was 1500mm. The Soil-cement column was constructed by 8t class machine. Column's diameter was 500mm and length was 2.5m. Fig.18 shows deformation of the L-type retaining wall (precast). Preceding excavation at soil-cement column position was carried out, but the deformation occurred. The change of construction method should be examined in residential land when there is a retaining wall.
