## Survey Report of Liquefaction Damage of Urayasu Area

### ABSTRACT

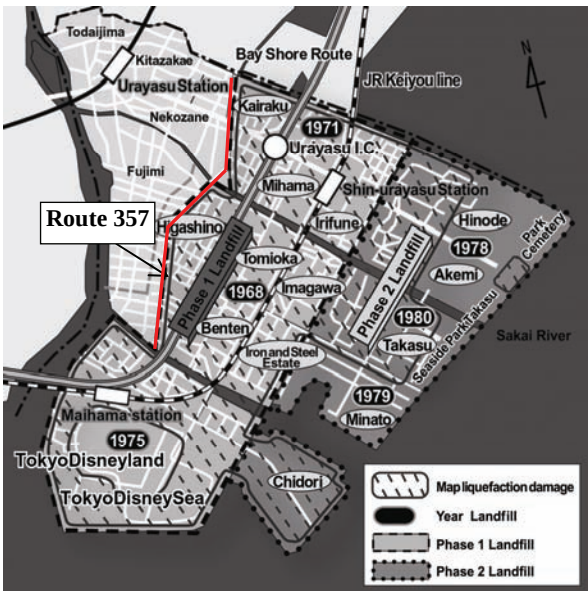
Fig.1(b) Liquefaction Warning Hazard Map in Urayasu city (Damaged area indicated by the hatched portion)

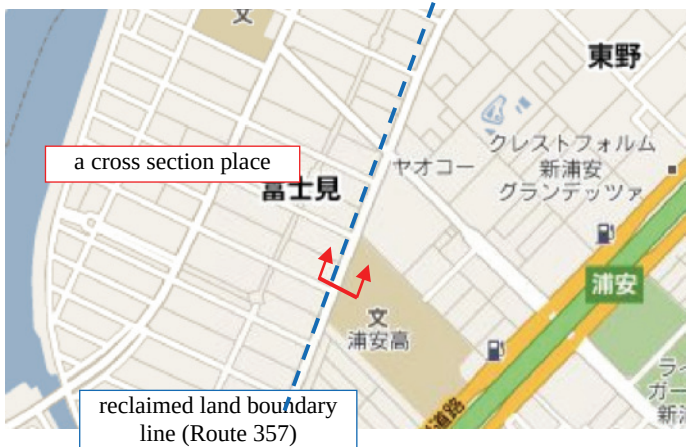
Photo.6 and Fig.2 show the boundary between Tohno area (right side; newly reclaimed land area) and Fujimi area (left side; original old residential area), and also the cross section of these two areas respectively. Right side of the road located in Tohno area was reclaimed with the same height to the old levee, and difference of road height between the right and left sides was about 80cm. As shown in Photo 6, damage level caused by liquefaction apparently depends on the ground condition where sand boiling was observed on the sidewalk

Fig.3 Location of newly reclaimed and old residential areas (by Google Map)

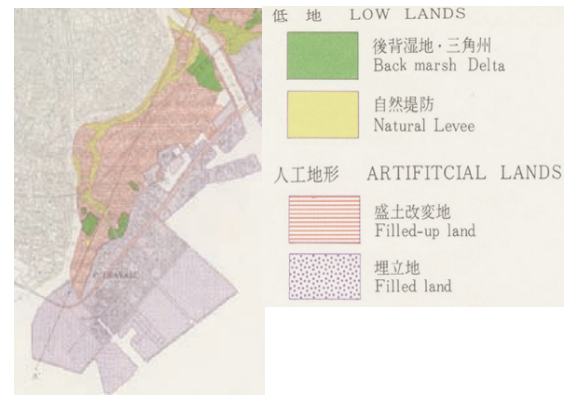
As shown in Fig.6, geographical features of Urayasu city are roughly classified into the Urayasu lowland, newly reclaimed land and embankment.

Fig.6 Geographical map of Urayasu city (by the Ministry of Land, Infrastructure, Transport and Tourism Website)

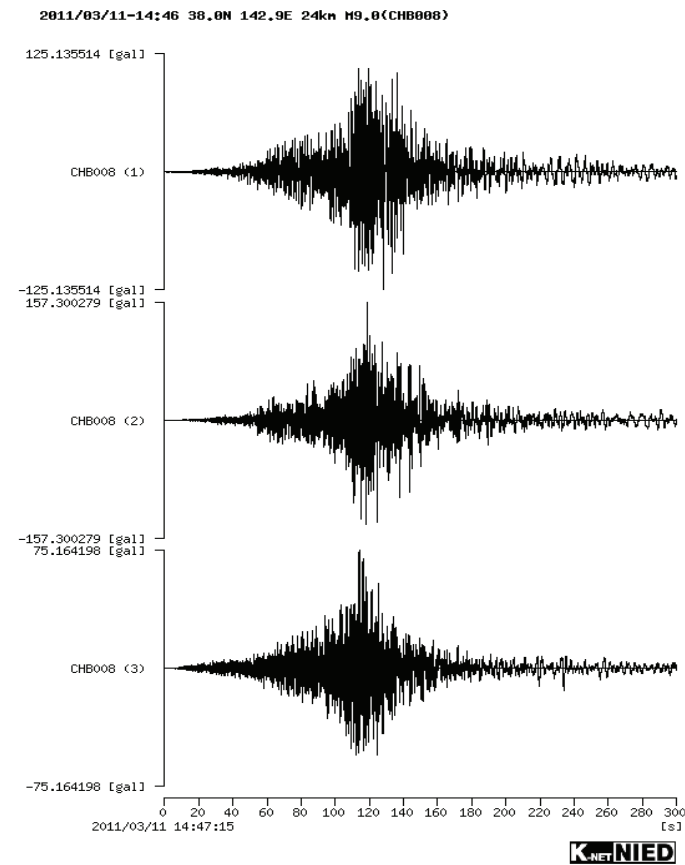
Urayasu area), damage to buildings and detached houses by the seismic (inertial) force was found to be small compared to that by liquefaction. Based on results of the spectrum analysis, it is reported that damage from the seismic wave of 1~2 second period, a range considered to increase damage to buildings by seismic force, was not significant in the earthquake. For example, in Sendai city, where level 6+ of maximum seismic intensity was reported, the observed seismic wave of 1~2 second period was only 20~30% of that of the Hanshin great earthquake (1995) where many more instances of total or partial destruction of 300,000 detached houses was reported. In the east Japan great earthquake, as the range of seismic waves less than 1 second period was relatively dominant, damage to building structures was far less than the Hanshin great earthquake. On the contrary, duration time of more than 300 seconds and large seismic force of the east Japan great earthquake are considered to enormously increase the total area of liquefaction and damage to the buildings and detached houses. Fig. 4 shows the seismic wave observed in Urayasu city for reference, in which the maximum acceleration and duration time are about 157 Gal and more than 5 minutes respectively.

Fig.4 Seismic wave observed in Urayasu City (from K-net)
